FINAL TECHNICAL REPORT

**FRETTING CORROSION IN AIRFRAME RIVETED
AND PINNED CONNECTIONS**

(Grant No. F49620-93-1-0488)

George T. Hahn and Carol A. Rubin

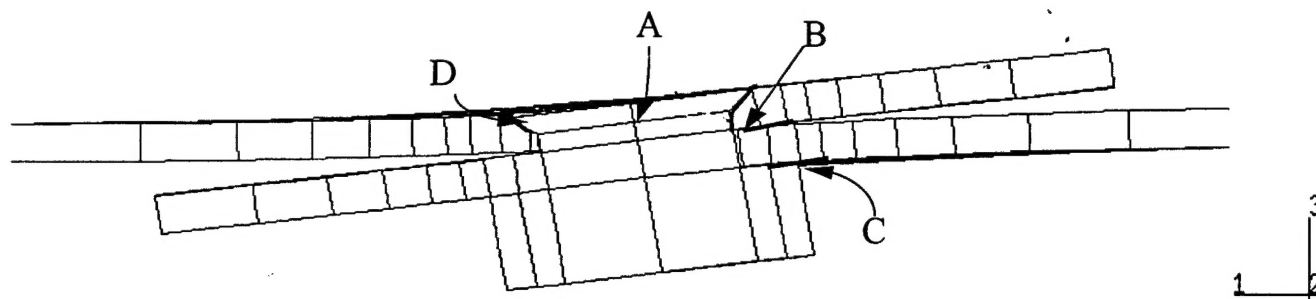
Figure 2. Regions of the joint interfaces where contact pressure and slip are combined with cyclic tension favorable for fretting fatigue: (A) rivet shank-panel interface (near the $\theta = 0^\circ$ and $\theta = 180^\circ$ angular locations) and (B) panel-panel interface where the edge of the lower panel hole rubs against the upper panel. Contact in regions (C) and (D) is attended by low values of cyclic tension and produce only fretting wear.

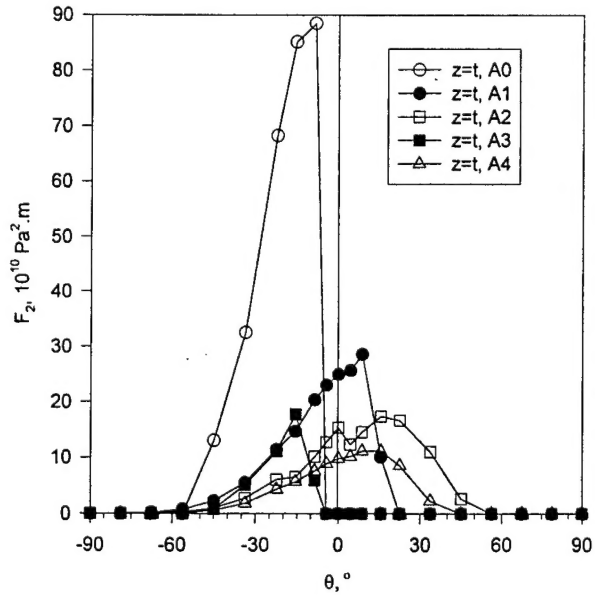
Figure 3. Effects of interference and clamping on the contact conditions and fatigue and fretting drivers at the rivet shank-panel interface of a lap joint (at the depth of the interior panel interface) including the angular variation of: (a) contact pressure, p , (b) slip amplitude, δ , (c) panel hole circumferential stress range, $\Delta\sigma$, and (d) fretting fatigue parameter, F_2 . The curves were obtained for a single rivet-row joint with conventional, non-countersunk rivet heads for 5 combinations of interference (I) and clamping (C): (A0) $I = 0\%$, $C = 0\%$; (A1) $I = 1\%$, $C = 0\%$; (A2) $I = 2\%$, $C = 0\%$; (A3) $I = 0\%$, $C = 0.5\%$; (A4) $I = 1\%$, $C = 0.5\%$.

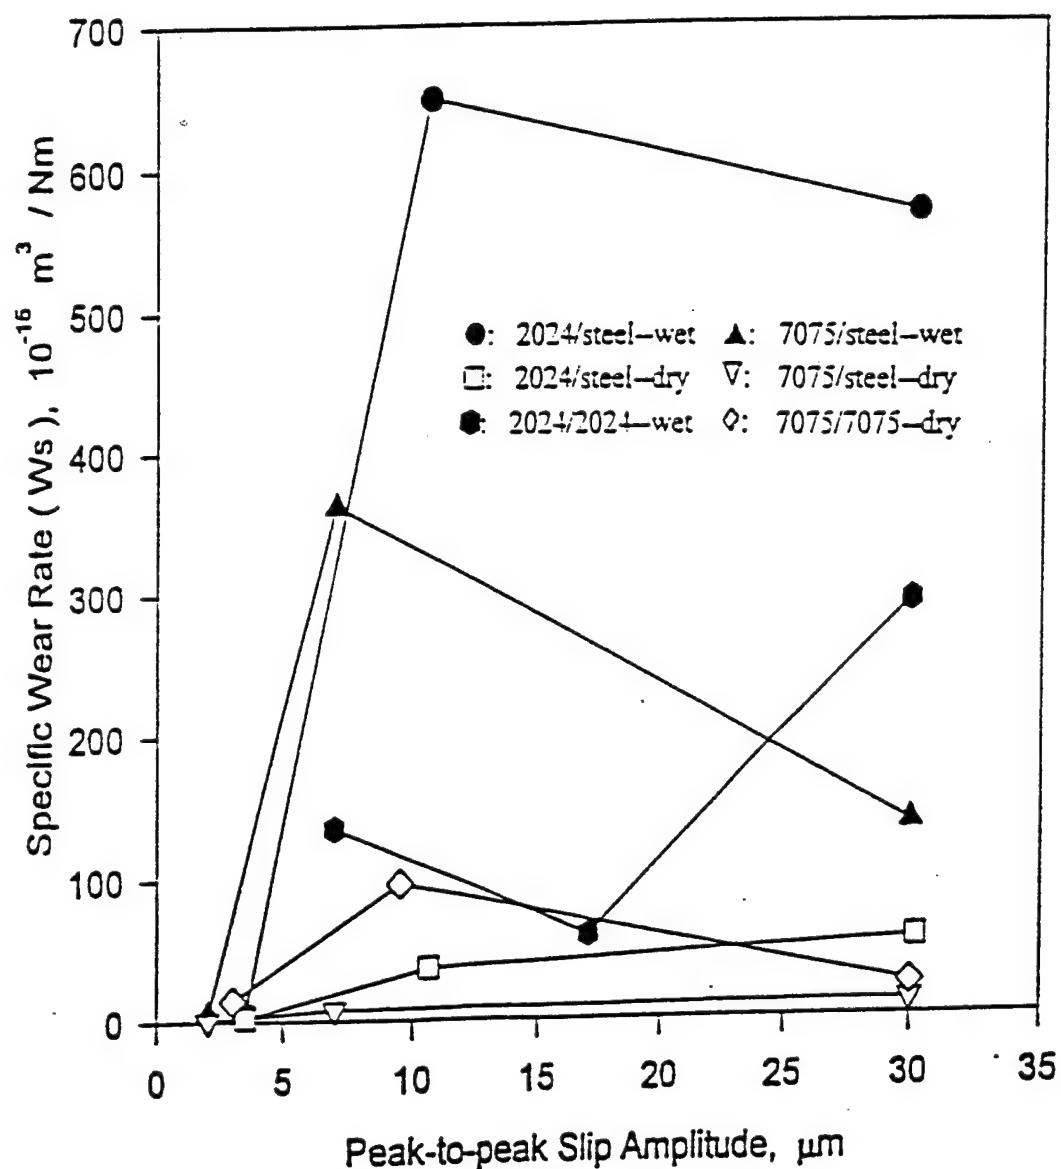
Figure 6 Variation of the specific fretting wear rate with slip amplitude for aluminum sheet alloys in contact with either aluminum or hardened steel and subjected to a nominal contact pressure of 408 GPa in laboratory air and 3.5% NaCl solution.

Values of the friction coefficient and specific fretting wear rates for contact between the following couples: 2024-T3 / 2024-T3, 7075-T6 / 7075-T6, 2024-T3 / hardened steel, and 7075-T6 / hardened steel under dry and corrosive conditions have been obtained. Examples of the results can be found in Figure 6 and in Appendices D and E. Corrosive conditions elevate the specific wear rate by 20-fold.

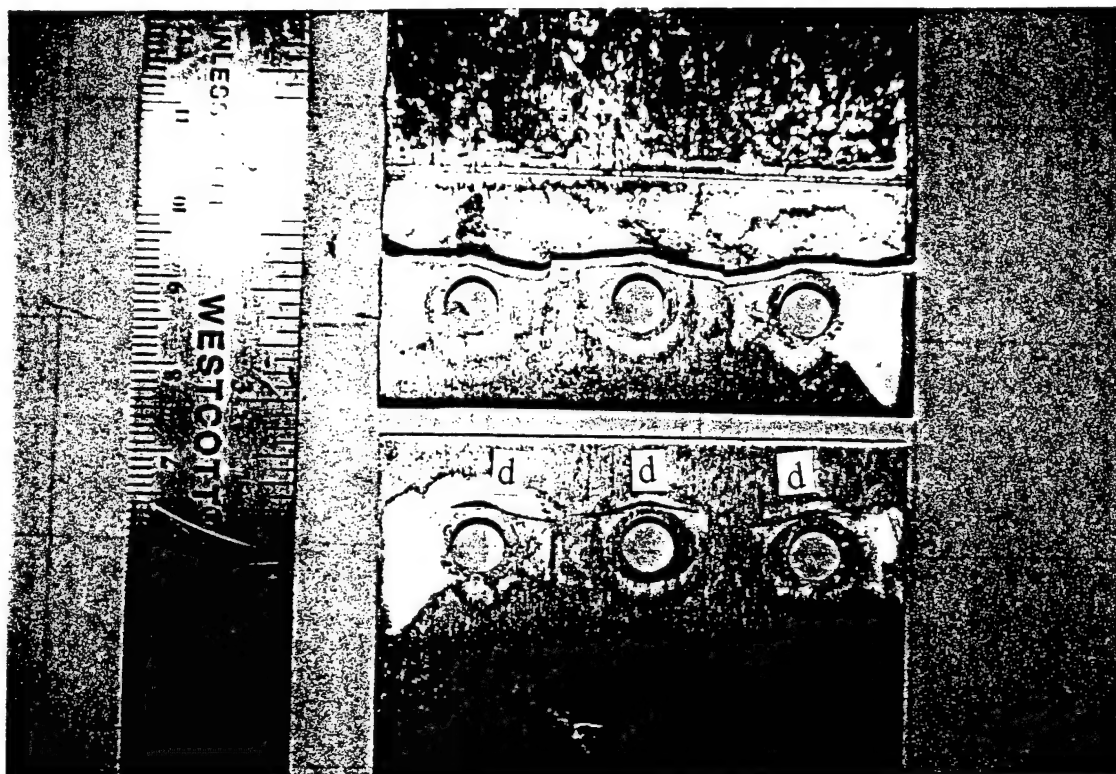
Figure 7 Failure of 3-rivet, 1-rivet-row test sample (sample 2 in Table 1) subjected to cyclic loading with a frequency of 0.1 Hz to a nominal stress of 50 MPa ($R = 0.1$) in 3.5% NaCl with an imposed anodic emf. The sample failed after 26,070 stress cycles compared with > 100,000 cycles for a cathodically protected sample (sample 1 in Table 1). Both samples were assembled with steel fasteners and displayed the same type of fracture.

Unlike the failures illustrated in Figure 3 where the failure originated at the hole edge of the upper, countersunk panel (refer to Figure 1) of a joint fastened with aluminum rivets, this failure originated remote from the hole in the lower, noncountersunk panel. The failure is believed to be related to the high stresses at the interior surface of the lower panel (see location B in Figure 2), and the effects of the lateral clamping produced by the stiffer, steel fasteners. Fretting wear damage produced by the fracture edge is visible at (d).

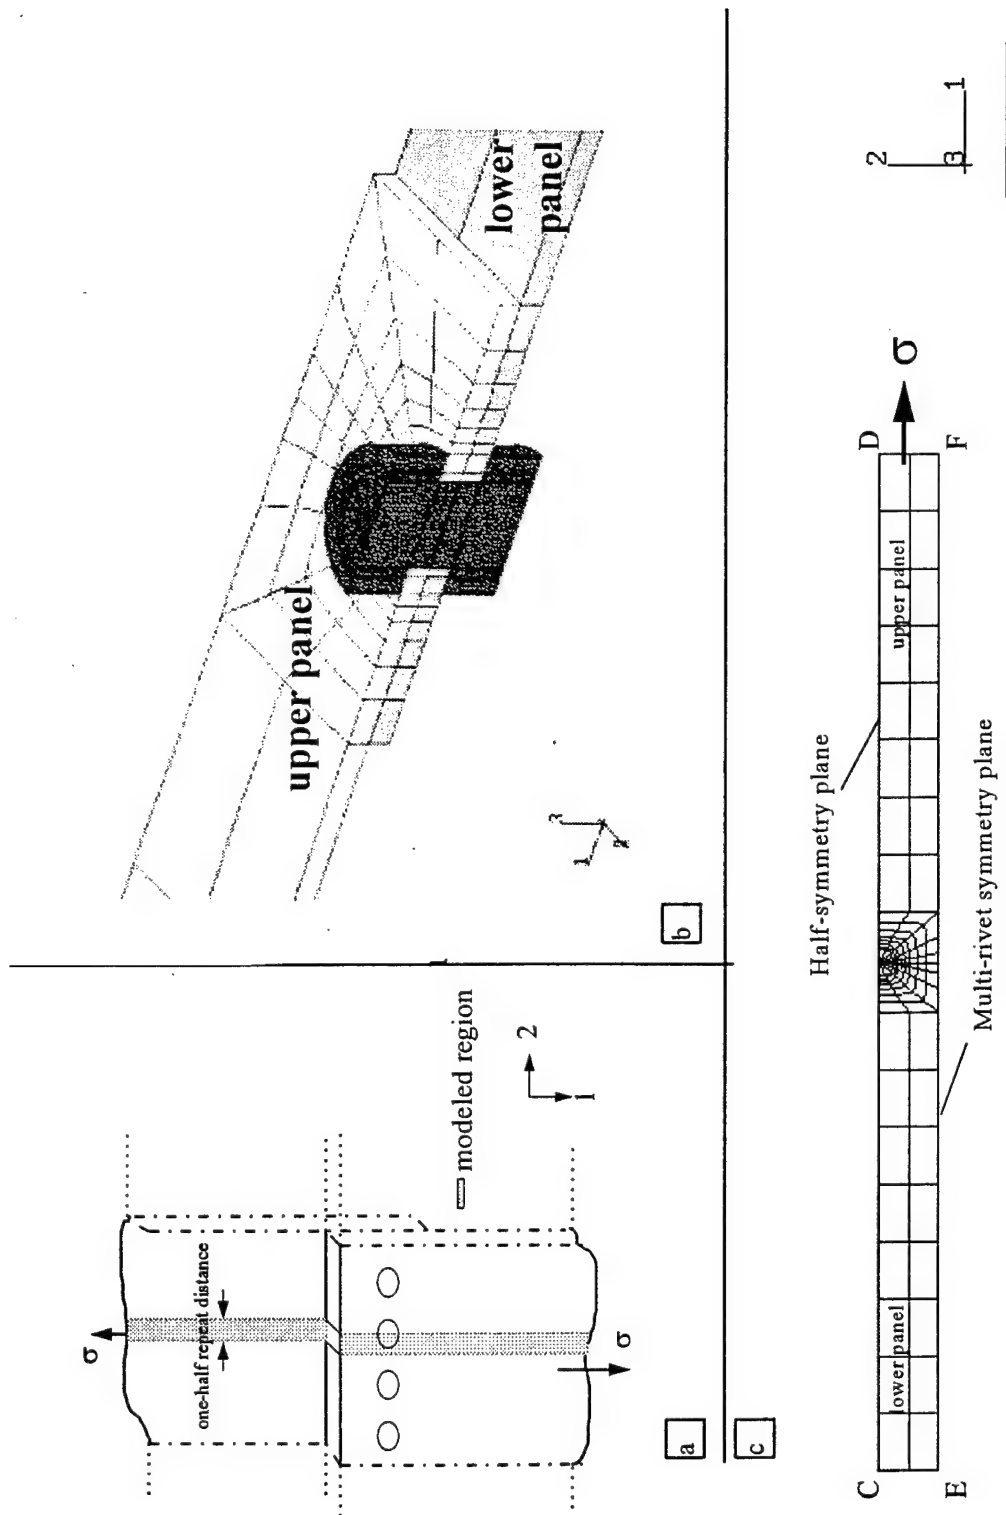
Figure 1. (a) Multi-riveted, single rivet-row lap joint, of which one half-unit is considered for the 3D half-symmetry finite element model, (b) the thickness of each panel is $t=1.53$ mm. The rivet is non-countersunk with a shank diameter of 6.12 mm; the rivet head diameter and height are 9.792 mm and 3.83 mm respectively, (c) plan view of the mesh. The overall length of the model is 306 mm, the length of the overlap region is 30.6 mm and the width of the model (half the repeat distance) is 15.3 mm.

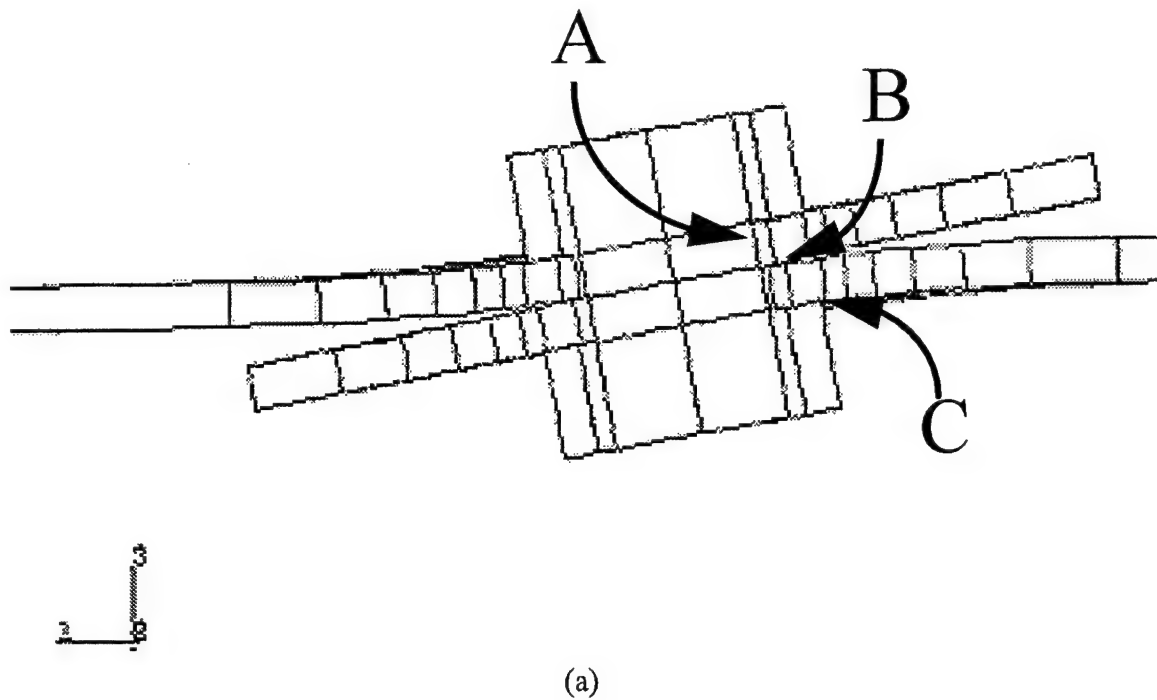
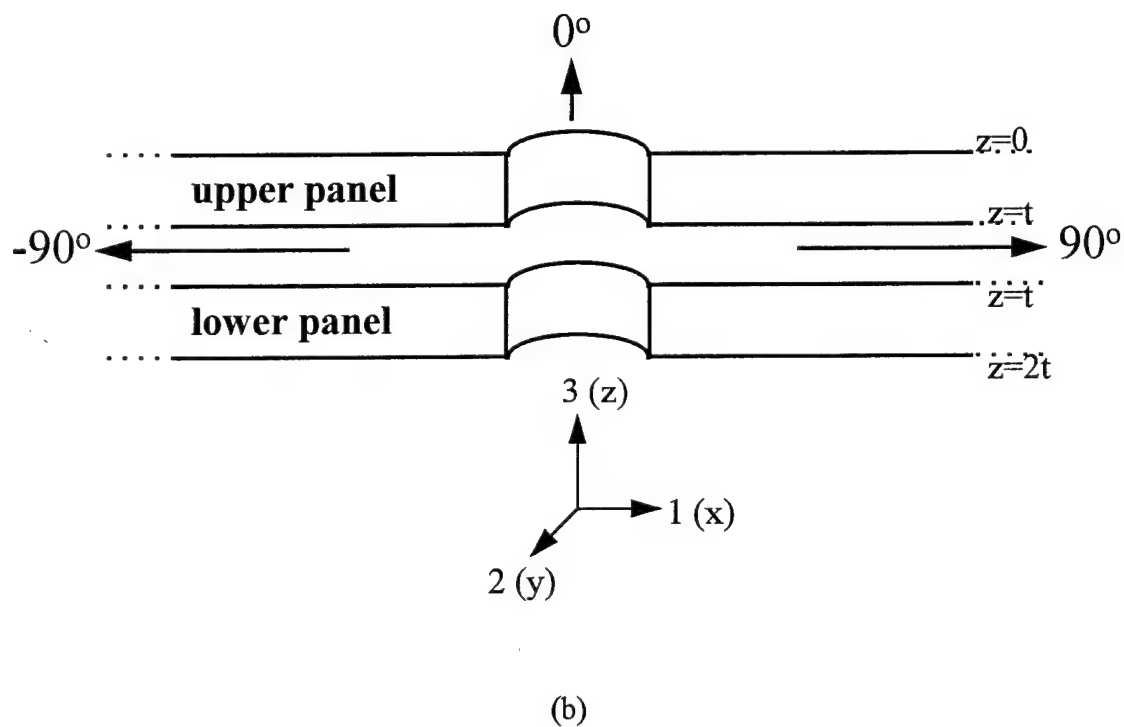
Figure 2. (a) Profile of a deformed mesh showing the three main rivet-panel and panel-panel fretting fatigue contact locations, (b) Schematic showing the definition of the angular locations and depth in the models.

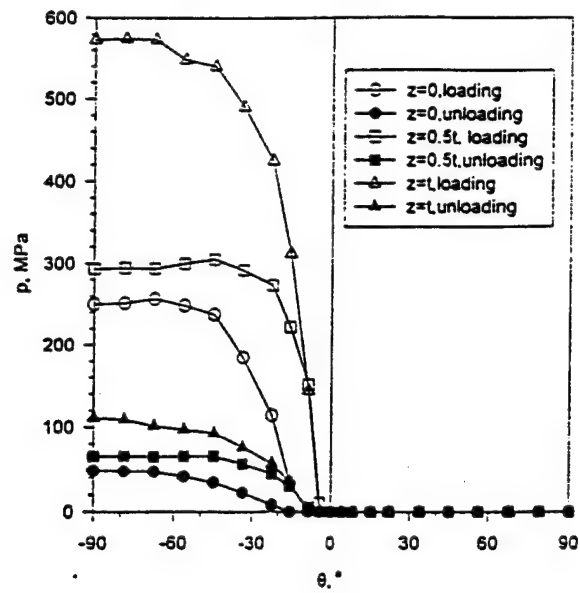
Figure 4. (a) Variation of contact pressure at the shank-hole interface with angular location and depth for Model A0, (b) Variation of contact pressure with angular location at depth $z=t$, where contact pressures peak, for Models A1 and A2.

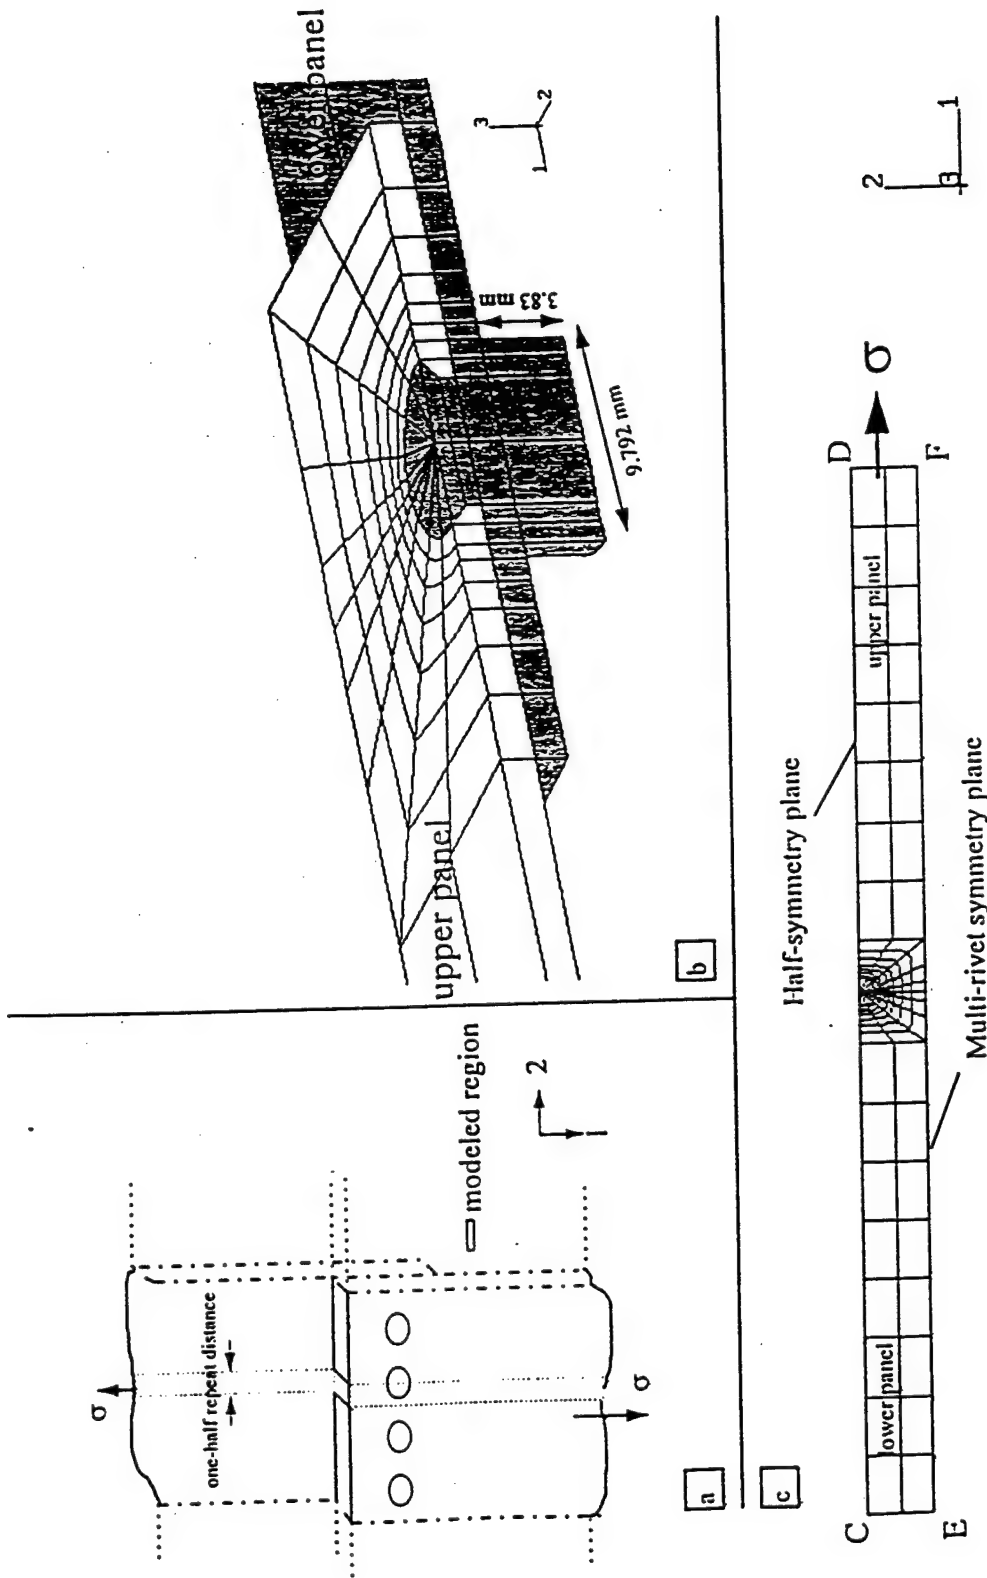
Figure 1. (a) Multi-riveted, single rivet-row lap joint, of which one half-unit is considered for the 3D half-symmetry finite element model, (b) the thickness of each panel is $t=1.53$ mm. The rivet is countersunk with an included angle of 100° and a shank diameter of 6.12 mm; the rivet head diameter and height are 9.792 mm and 3.83 mm respectively, (c) plan view of the mesh. The overall length of the model is 306 mm, the length of the overlap region is 30.6 mm and the width of the model (half the repeat distance) is 15.3 mm.

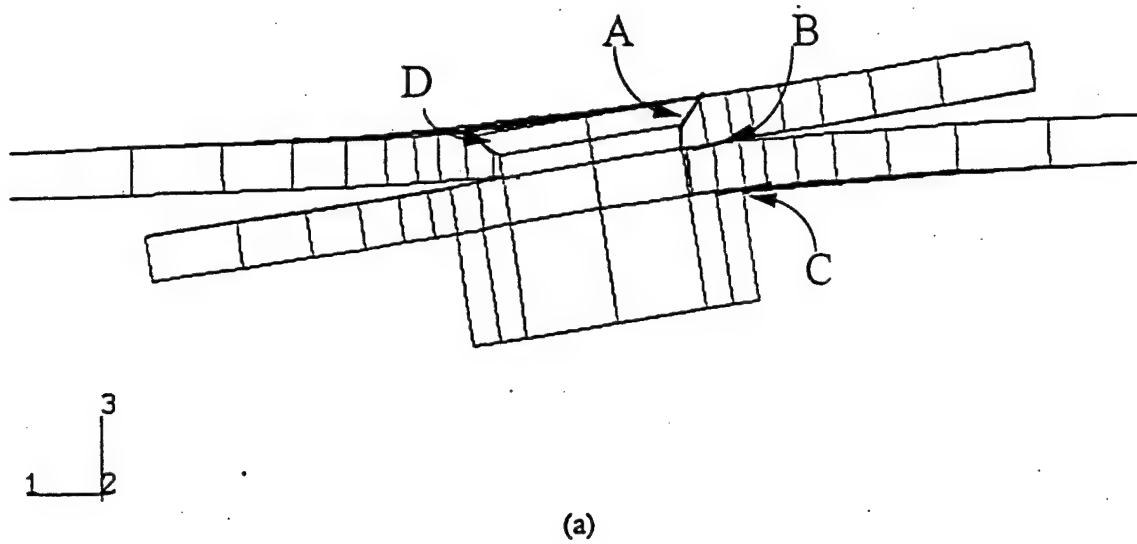
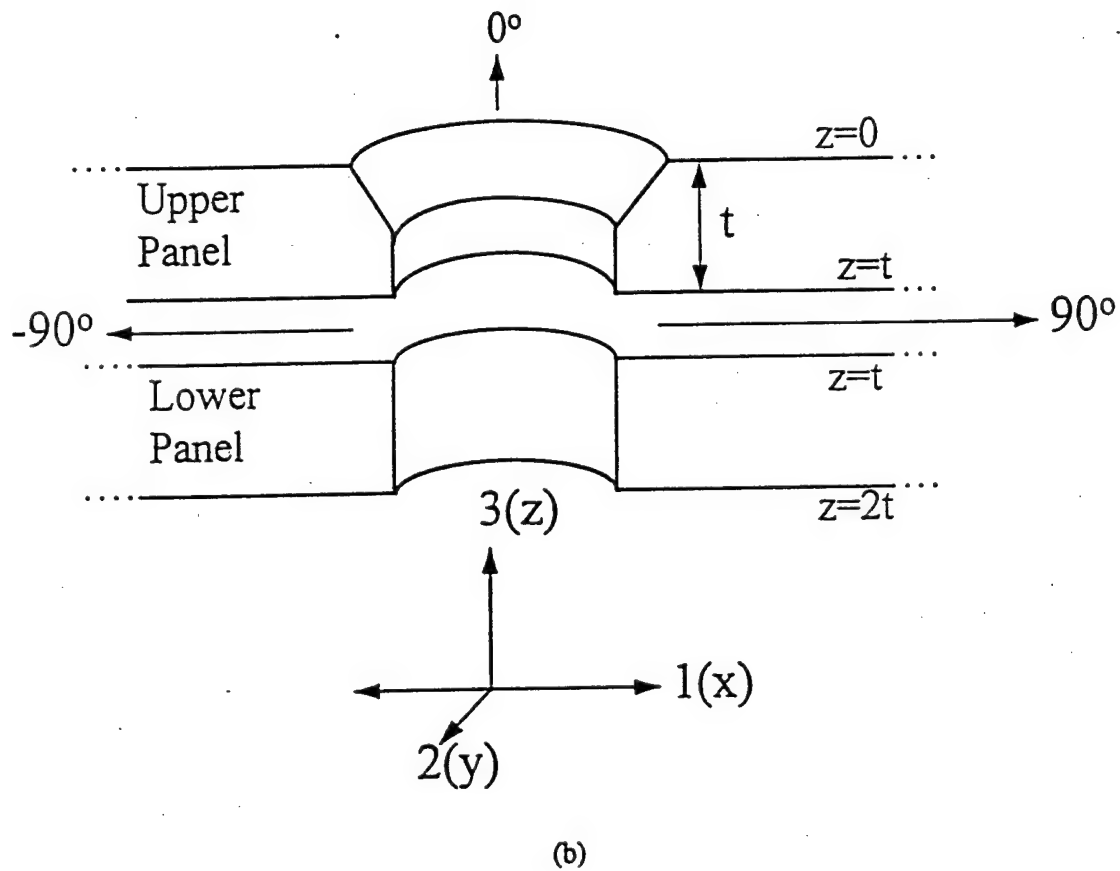
Figure 2. (a) Profile of a deformed mesh showing the four main rivet-panel and panel-panel fretting fatigue contact locations, (b) Schematic showing the definition of the angular locations and depth in the models.

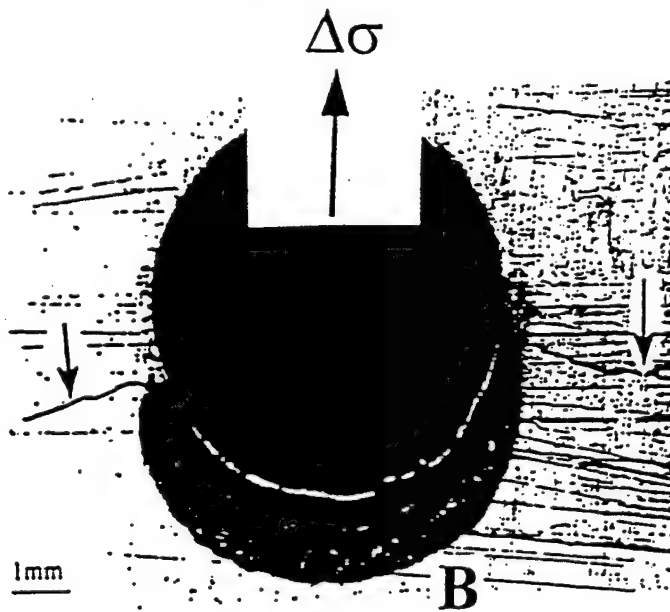
Figure 3. Important fretting fields observed in laboratory tested riveted lap joints.

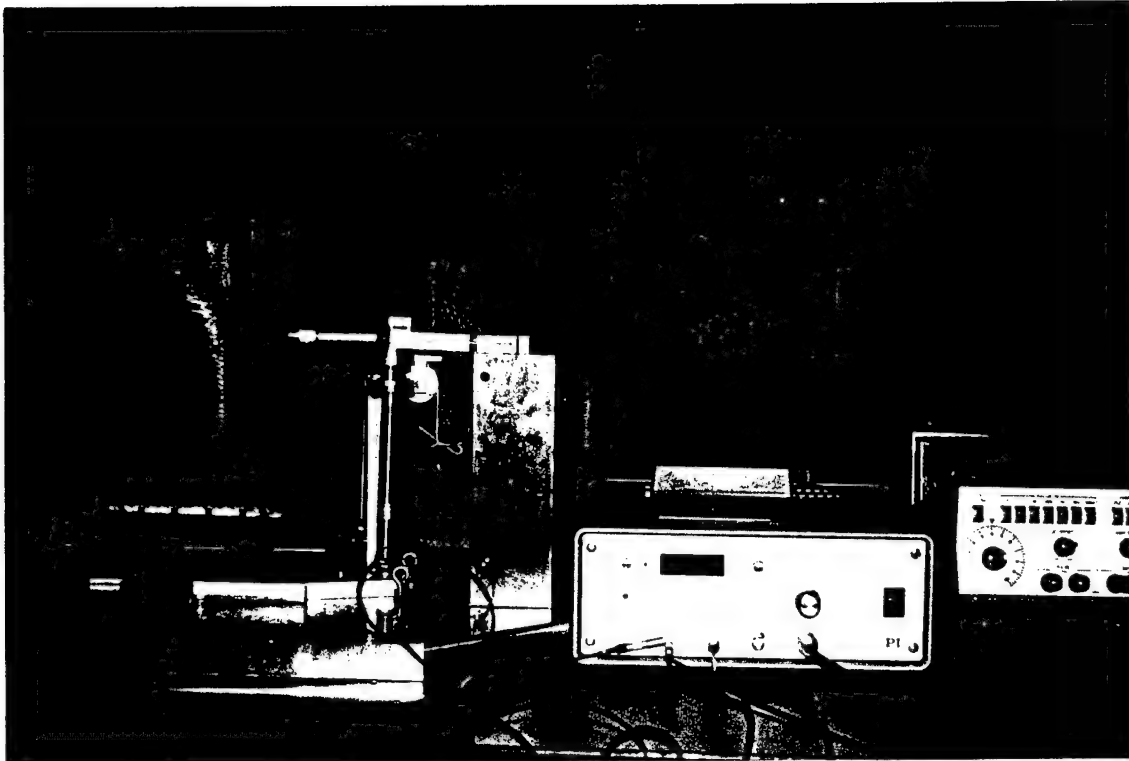
Figure 1 Overview of the fretting wear machine

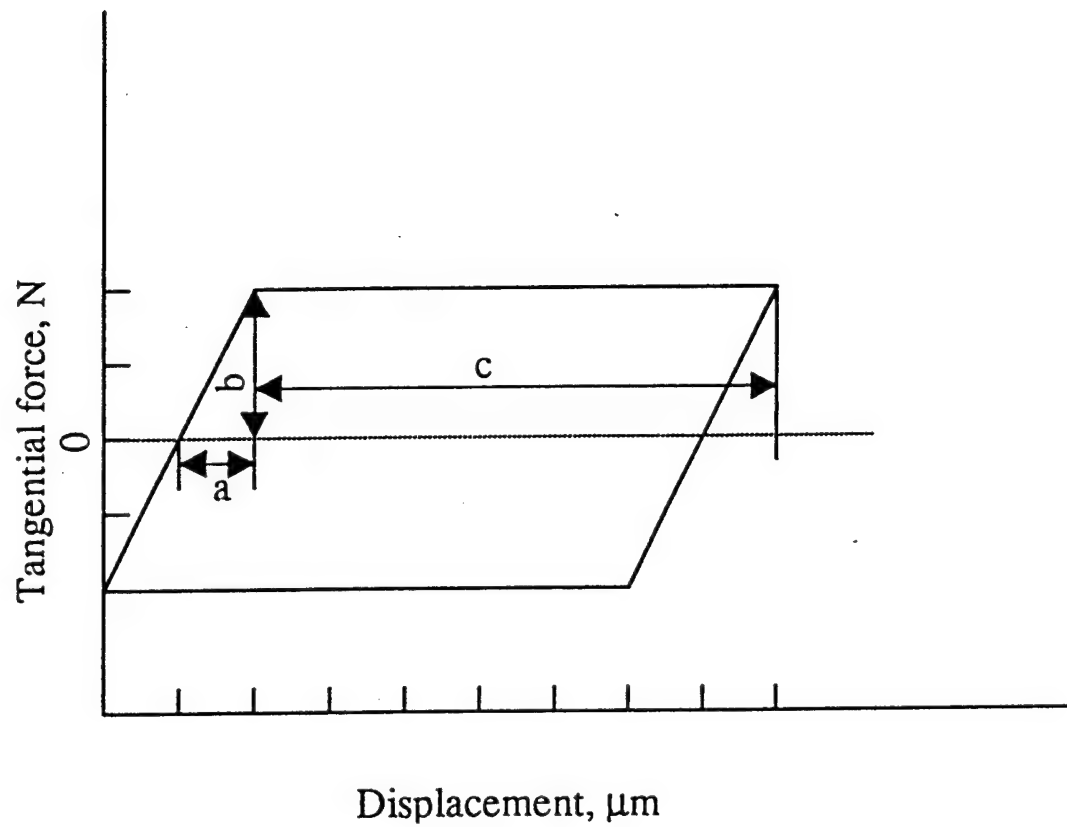
Figure 4 Schematic drawing of a typical tangential force-displacement (Ft-D) hysteresis loop. a/b defines the system compliance and c is the local slip amplitude.

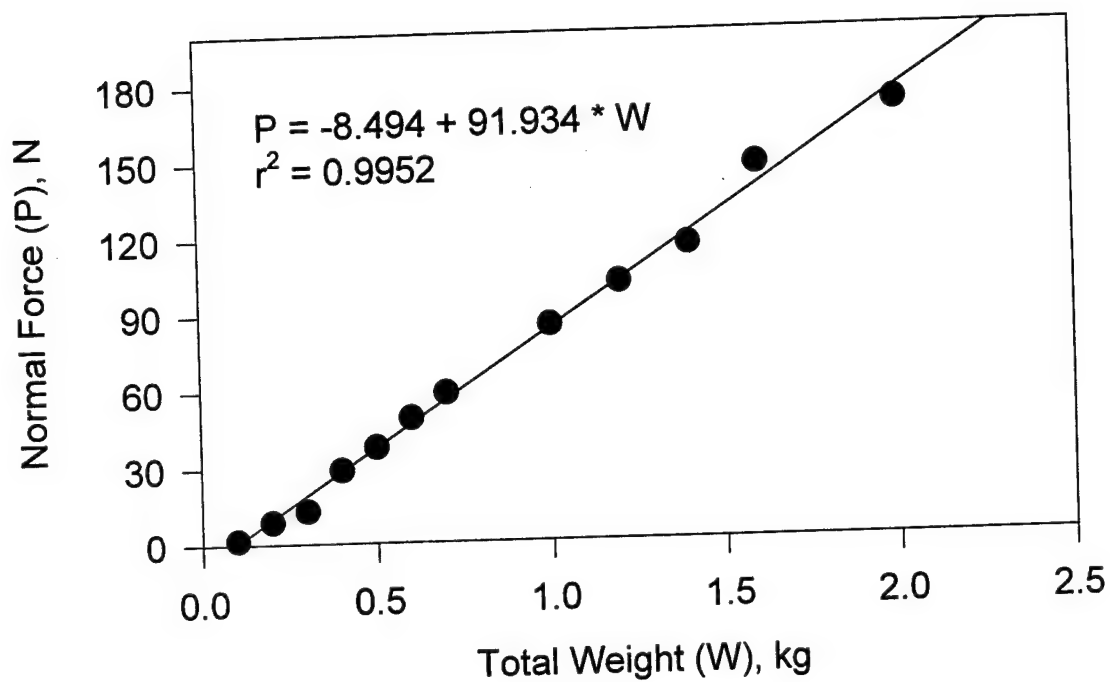
Figure 5 Calibration curve of the normal force.

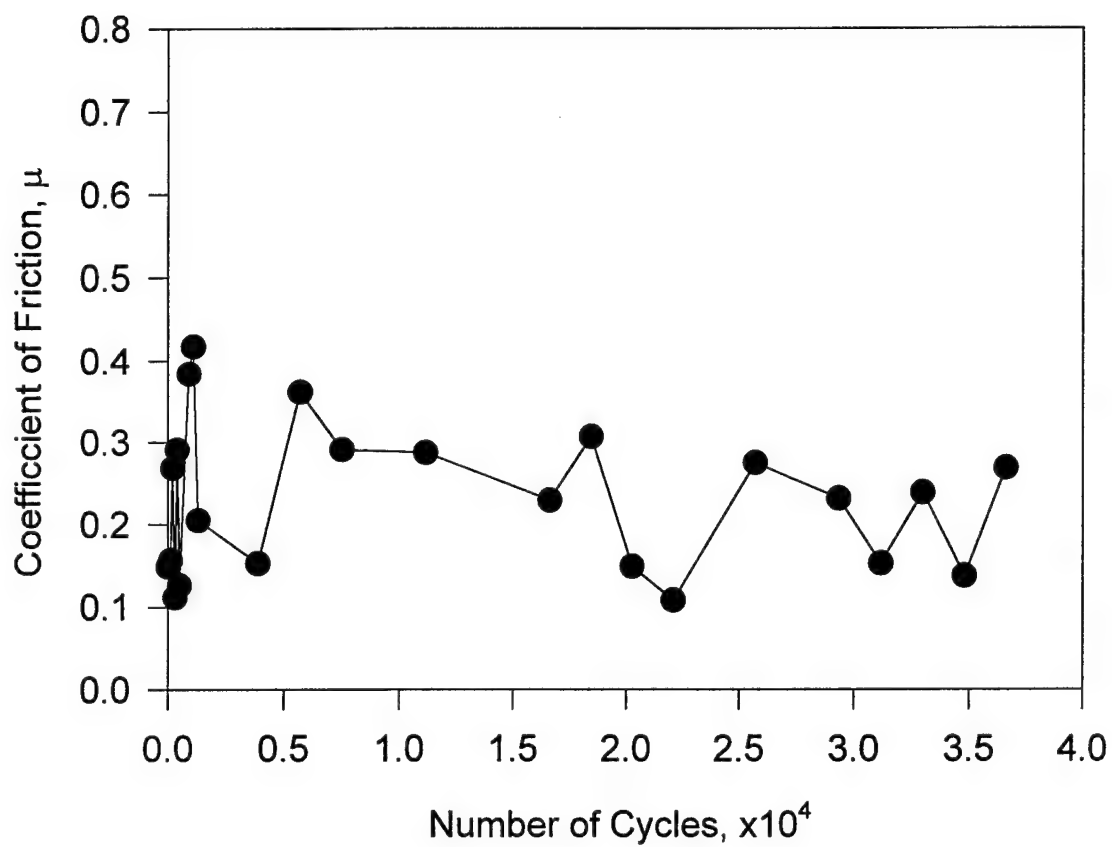
Figure 8 Plot of coefficient of friction against number of fretting cycles for 7075-T6 in 3.5% NaCl solution at 40 μm displacement, 37.3 N normal force and 1 Hz frequency.

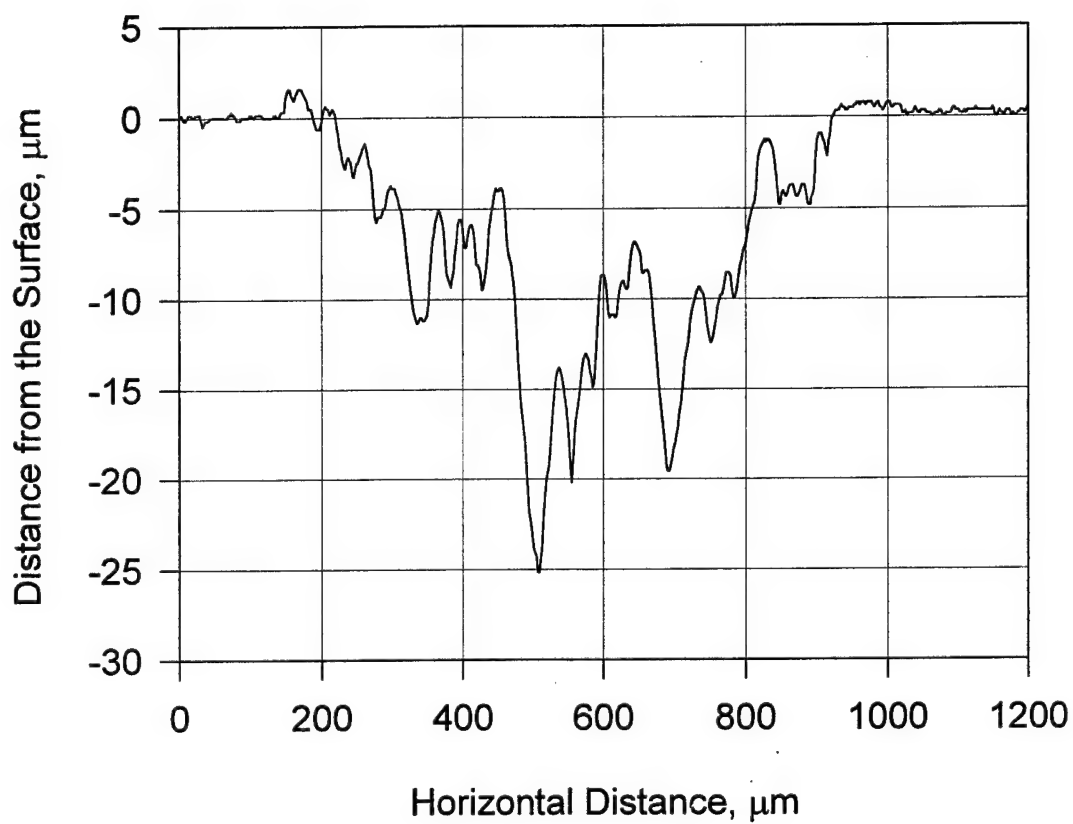
Figure 9 Profile of fretting wear scar of 7075-T6 specimen after $N = 40,000$ cycles in 3.5% NaCl solution. Total displacement is $40\text{ }\mu\text{m}$ and normal force is fixed at 37.3 N.

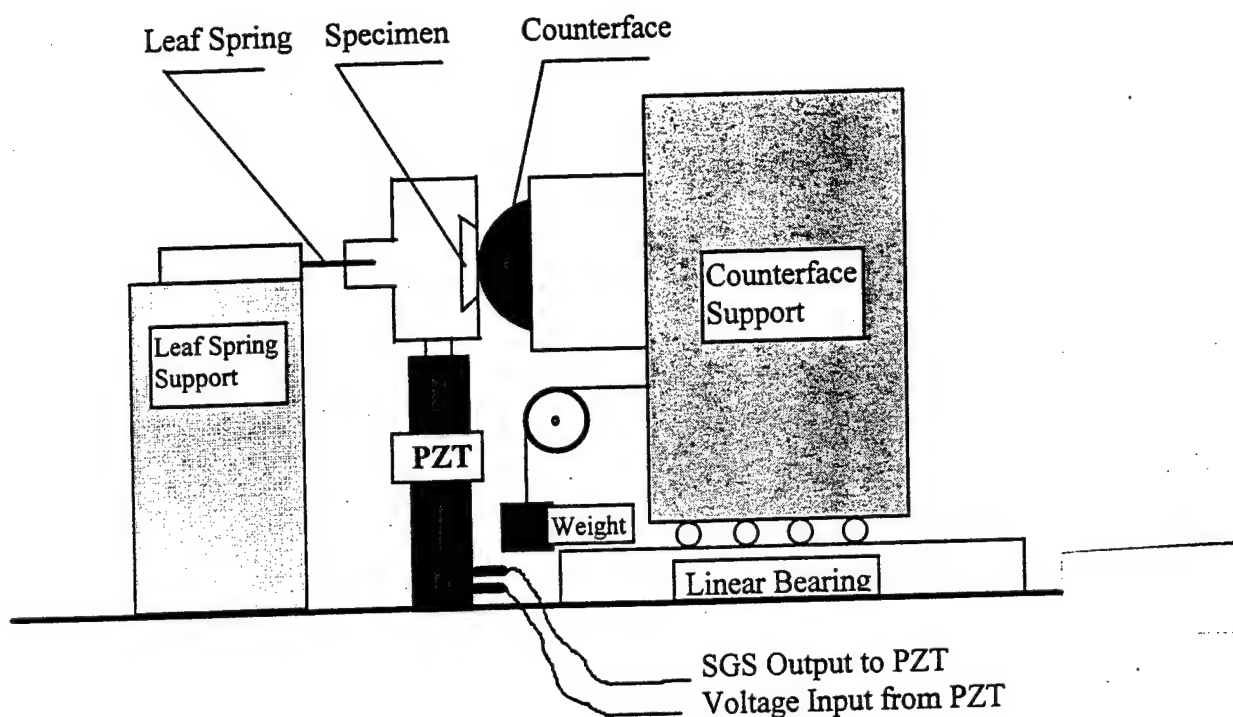
Figure 1 Schematic diagram of the fretting wear machine (mechanical part)

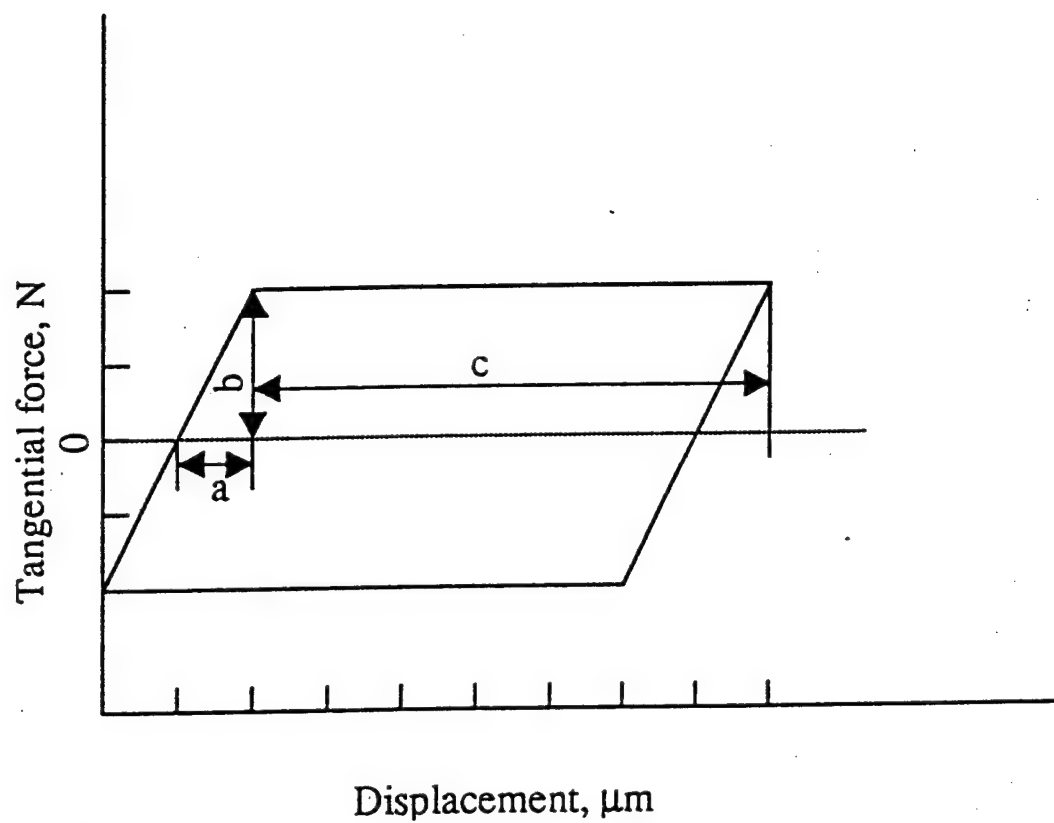
Figure 2 : Schematic drawing of a typical tangential force-displacement (Ft-D) hysteresis loop. a/b defines the system compliance and c is the local slip amplitude.

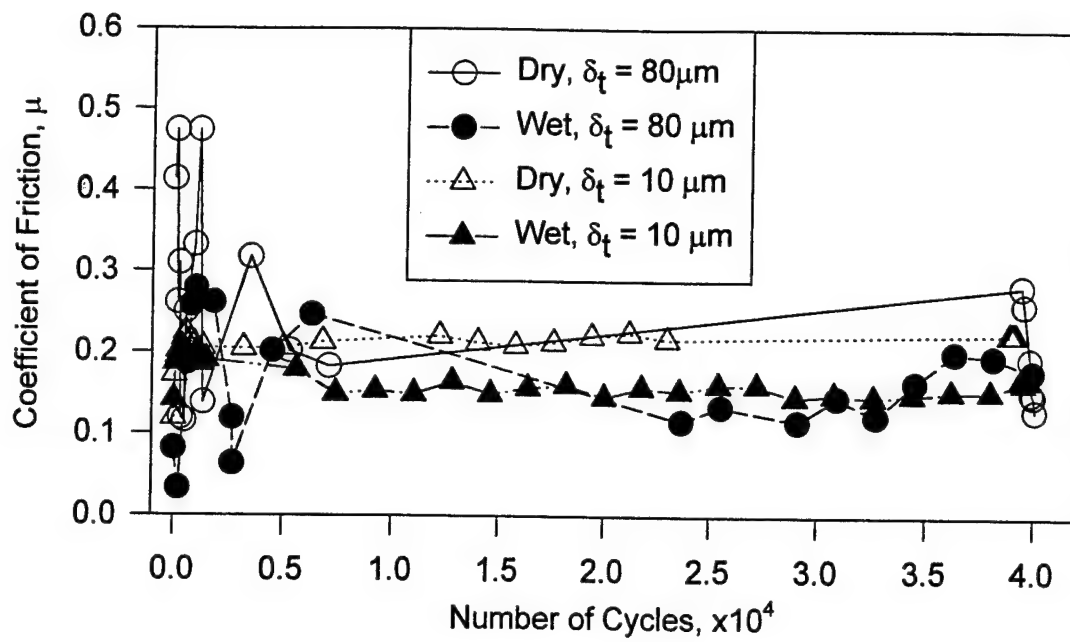
Figure 4 Typical friction coefficient curves as the function of number of fretting cycles for 2024-T3 fretting against a 52100 steel ball in both dry and wet conditions.

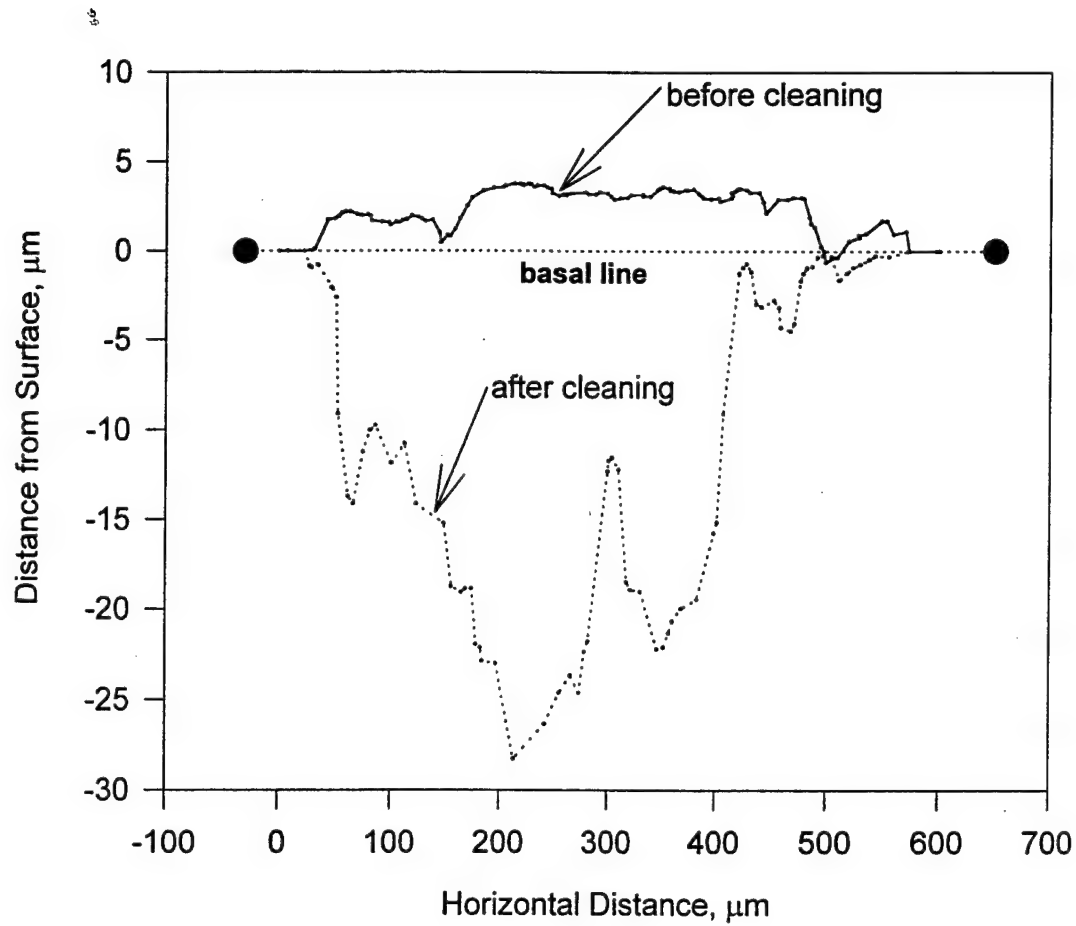
Figure 5 Profilometer measurements of the wear scars produced by $N = 10^4$ fretting cycles for a 2024-T3 sample against a steel ball in ambient air for a contact pressure $p_0 = 407$ MPa. Fretting produces a build-up of debris. Removal of the debris by washing reveals a 25 μm -deep wear scar.

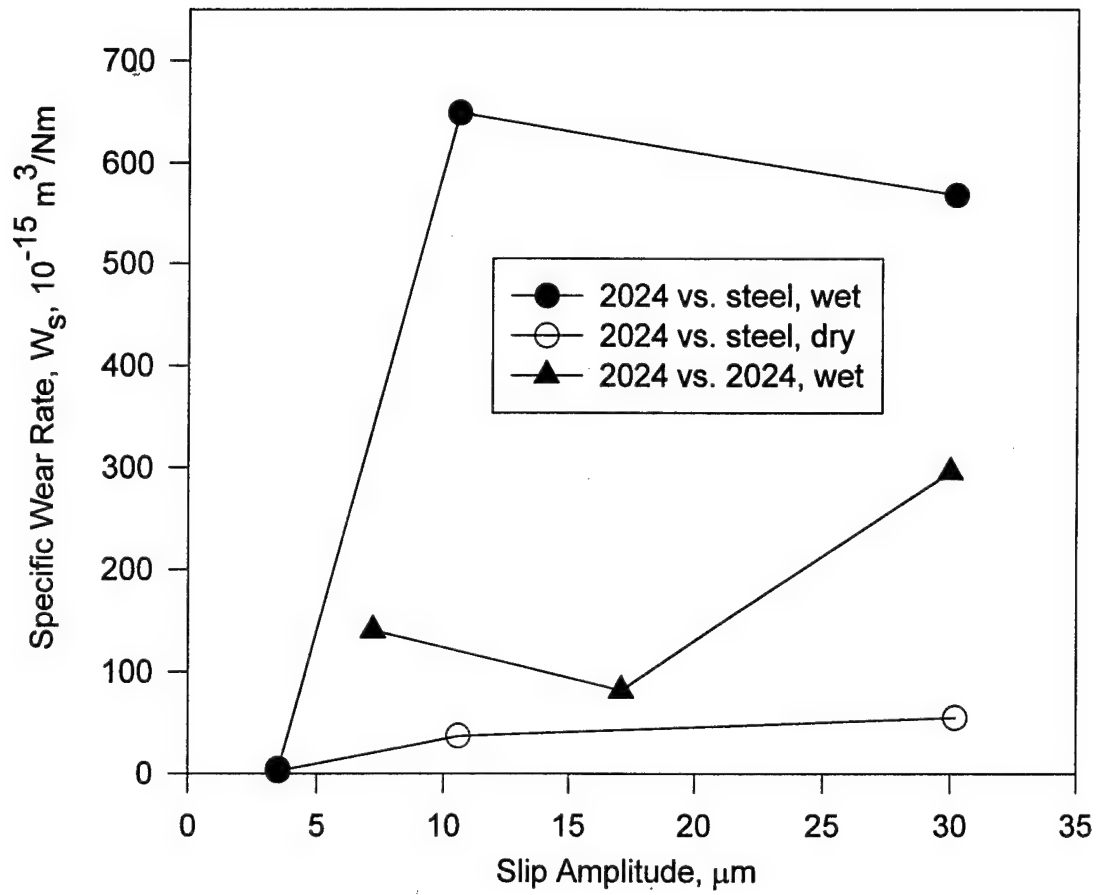
Figure 7 Variation of the specific wear rate, W_s , with slip amplitude for 2024-T3 against a 52100 sphere or 2024-T3 hemisphere in air and in a 3.5% NaCl solution after $N = 1 \times 10^4$ fretting cycles for $p_0 = 407 \text{ MPa}$ and $f = 1.0 \text{ Hz}$.

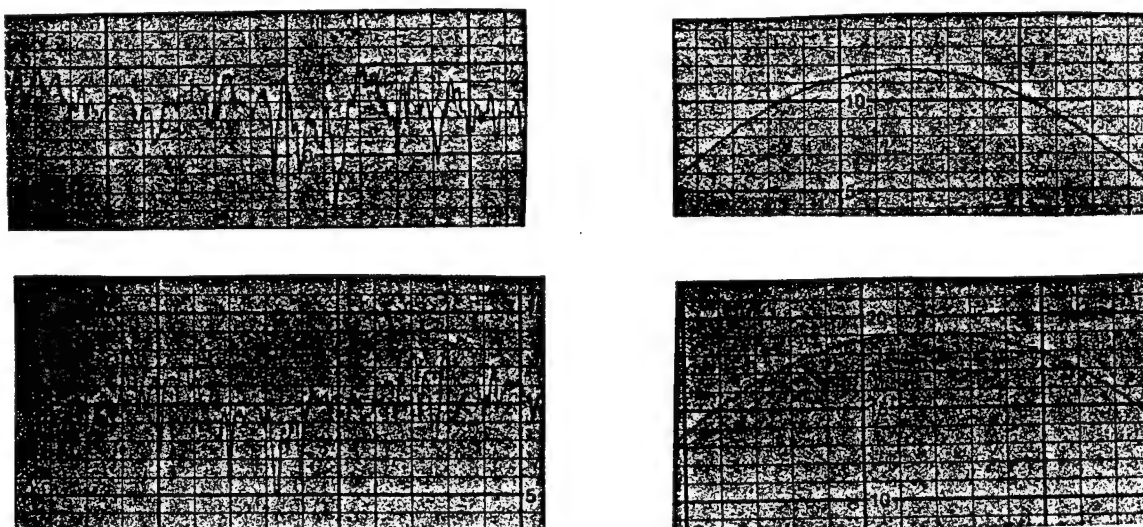
Figure 9 Profilometer traces of the aluminum sample and steel ball after cleaning, after (a) 500 fretting cycles, (b) 50,000 cycles, 20K \times , for $p_0 = 407$ MPa, $\delta_t = 10$ μ m.

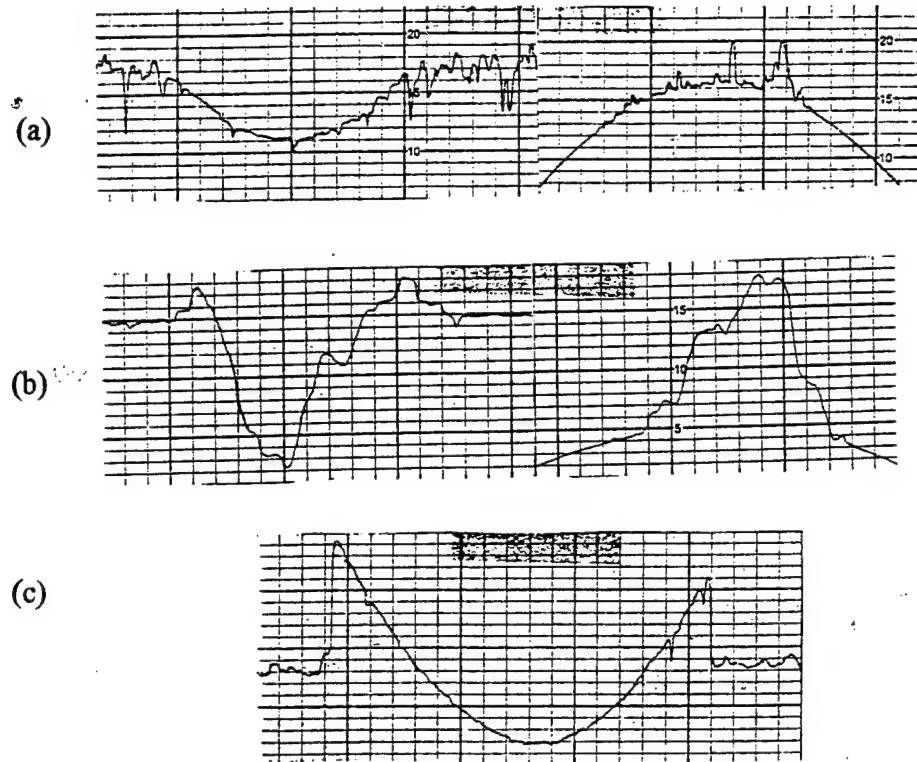
Figure 10 Profilometer traces of 2024-T3 sample and steel ball prior to cleaning, after (a) 500 fretting cycles, 10K \times , (b) 50,000 cycles, 2K \times , and (c) perpendicular to (b) for $p_0 = 407$ MPa, $\delta_t = 25$ μ m.

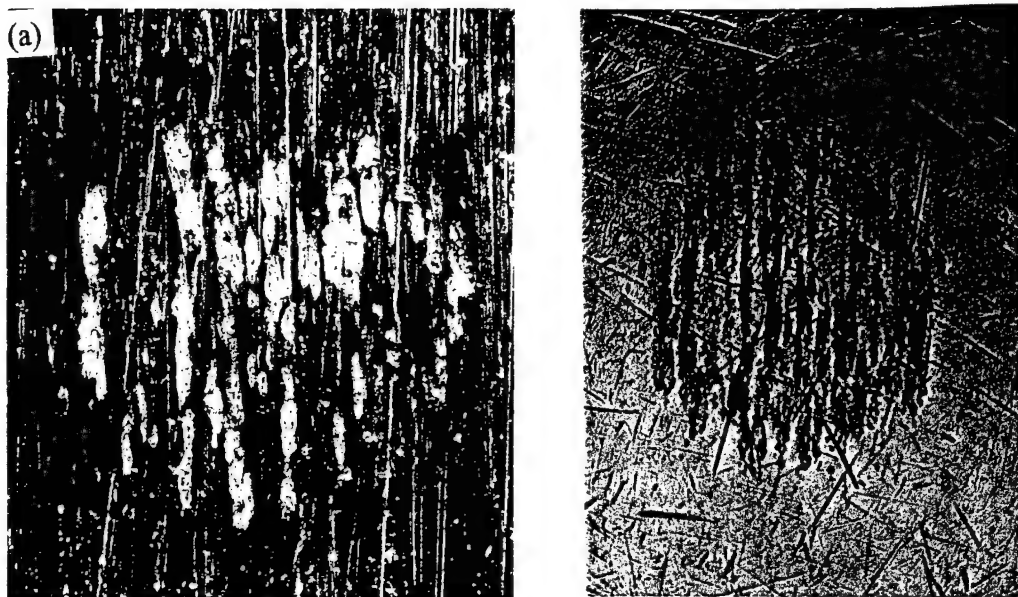
Figure 12 SEM and optical images of (a) 2024-T3, and (b) the counterface for 5,000 cycles with a frequency of 1 Hz under $p_0 = 407$ MPa for $\delta_t = 10$ μm .
